ST. GEORGES BRIDGE. BRIDGE INSPECTION REPORT NUMBER 11A.(U)

20. ABSTRACT (Continue on reverse side if necessary and identify by block number) - This report presents the findings and recommendations for the 1979 inspection of the St. Georges Bridge (route designation, U.S. Route 13) which crosses the Chesapeake and Delaware Canal. Technical information is given on the condition of the main and approach piers, access stairways, abutments, superstructure steelwork, paint, bridge deck, railings, drainage and general site.

The findings and recommendations of the 1979 inspection of the St. Georges Bridge (Route designation, U.S. Route 13) which crosses the Chesapeake and Delaware Canal was undertaken for the Department of the Army, U.S. Corps of Engineers by Howard Needles Tammen & Bergendoff (HNTB) and are submitted herein. A location map is presented in Drawing 1-0.

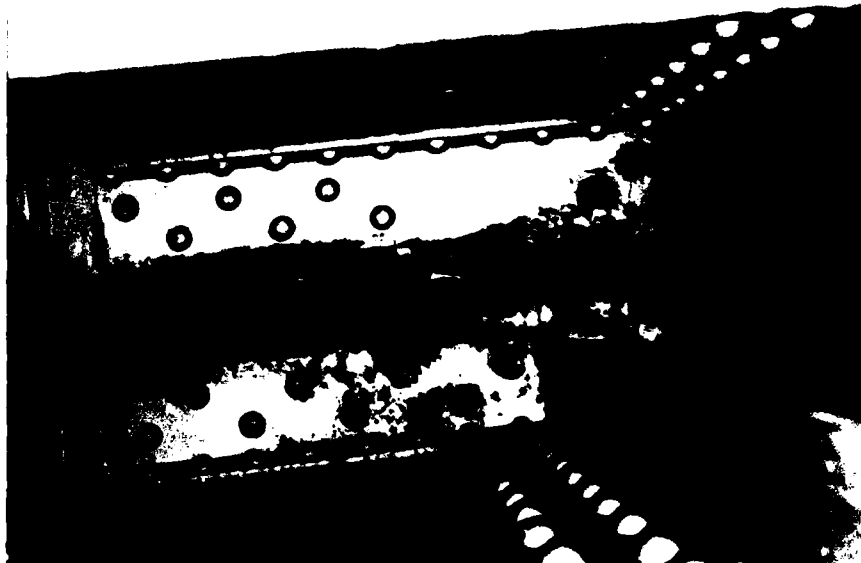
Photograph 12 - Typical deterioration of upper flange angles of floorbeam of a girder span adjacent to leaking expansion joint. Plate used to form concrete at joint is severely deteriorated. Unfilled rivet holes in the flange of floorbeam are rusting.

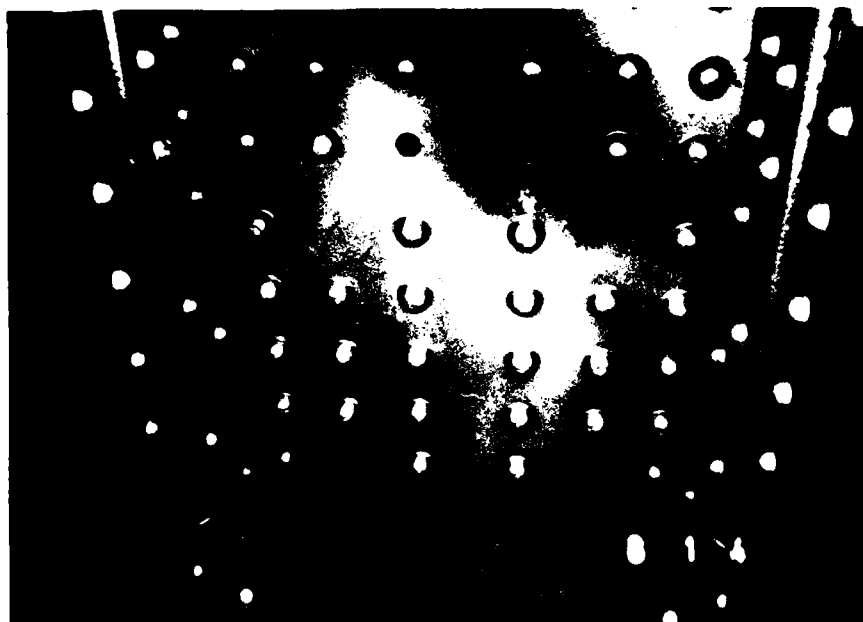
At these locations there are rivet holes only in one of the members that were to be connected.

Photograph 18 - Missing rivets in upper splice plate and interior diaphragm, in the interior of tied arch located north of L6'.

The missing rivets should be replaced with high strength bolts and tightened in accordance with the AASHTO requirements; this will require a bolt hole to be drilled in one of the members to be connected.

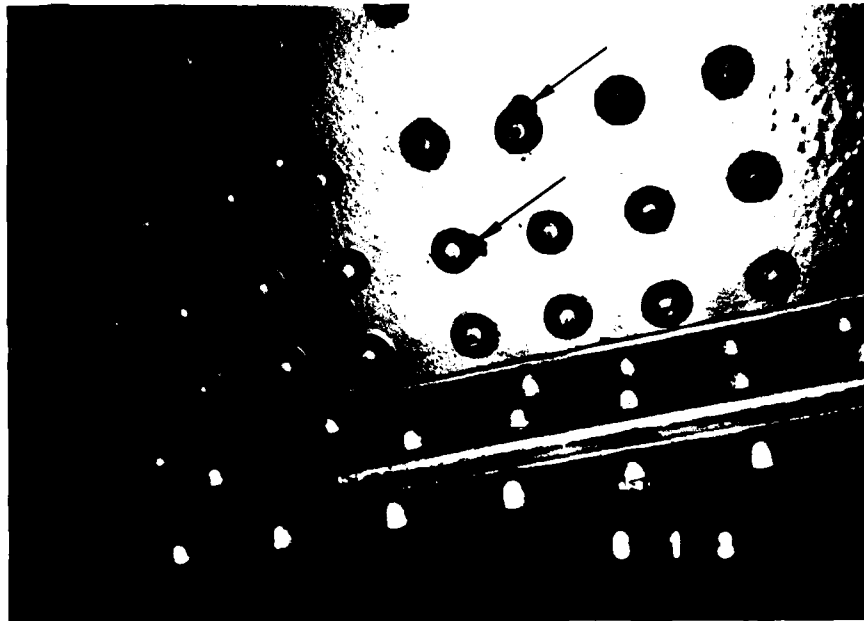
There are two rivets on the upper plate of the west tie girder at L4' that are in oversized holes. (See Photograph 19.) These holes should be periodically checked for any signs of distress.

Photograph 19 - Oversized holes adjacent two rivets in upper plate of interior of tied arch at L4.

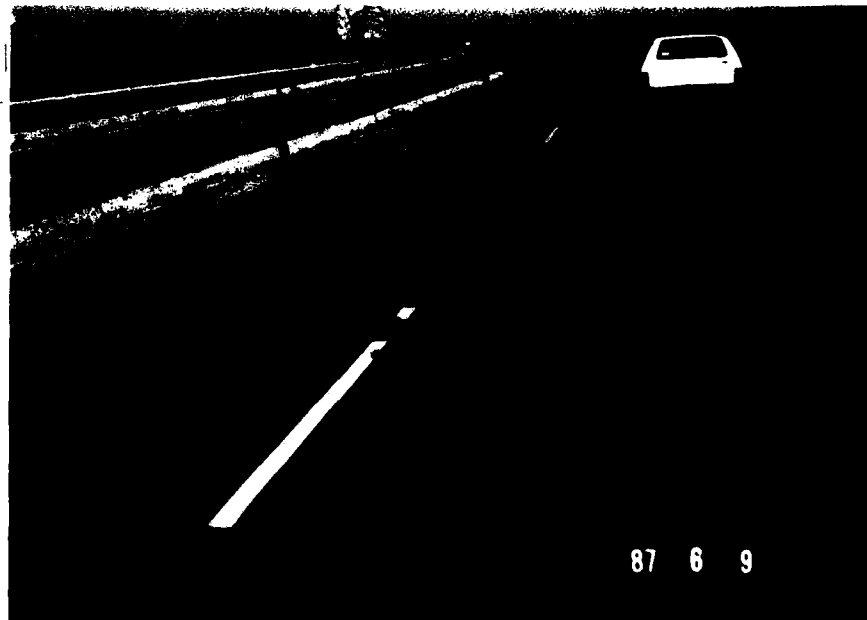
- Span 17S-18S - left southbound lane - There is a 6'x 15' spalled area with exposed reinforcing steel.
- Span 17S-18S - northbound lanes - There is a 10' x 15' spalled area with exposed reinforcing steel. (See Photograph 24.)
- Span 3S-4S - right northbound lane - There is a 6" diameter spall which is 1/2" deep.

Photograph 24 - Spalled pavement with exposed reinforcing steel in the northbound lanes between Piers 17S and 18S.
